Kubota Canada LTD. Recalls Zero Turn Mowers

Kubota Zero Turn Mowers

This recall involves model year 2016 through 2018 Kubota Z400 and Z700 series diesel-Powered zero turn mowers. The recalled units were sold in orange and black and have “Kubota” imprinted on the front and side of the mowers.

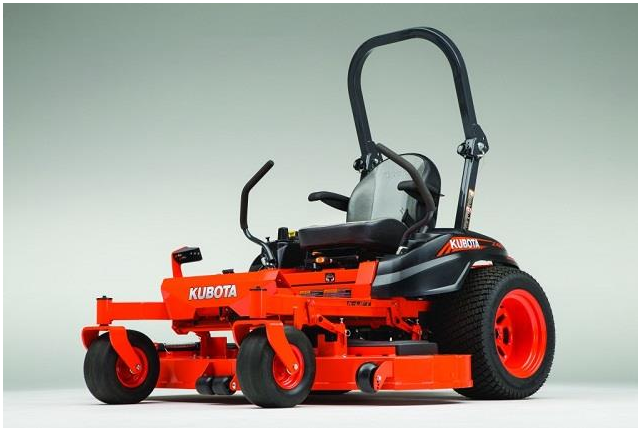
Image 1. Kubota Mower Z421KWT60

Kubota has discovered that the bolts on the rollover protective structure (RoPS) may not have been tightened sufficiently at the factory. As a result the rollover protective structure (RoPS) on the mower may loosen and fail to protect the operator in a rollover accident, posing a risk of injury.

Consumers should immediately stop using the recalled zero turn mowers and contact an authorized Kubota dealer for a free inspection and free repair of the rollover protective structure.

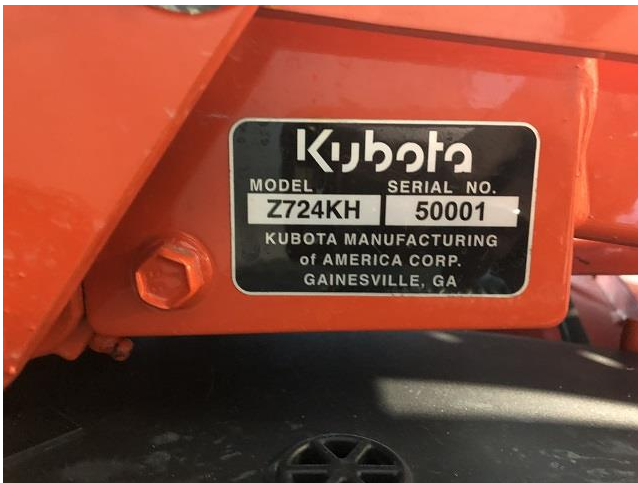
Image 2. Kubota Z Series Data plate

The model number and serial numbers can be found on the data plate located on the side of the unit.

The model and serial numbers for the affected Kubota Zero Turn Mowers sold in Canada are:	
Model	Serial range
Z411	12823 – 14587
Z421	15715 – 20127
Z723	50001 - 50176
Z724	50003 – 51130
Z725	50001 - 50657
Z726	50008 - 52361
