# Kubota Canada Ltd. recalls reserve coolant tank caps for various Ride-On Mowers, Utility Tractors and Zero Turn Mowers

Coolant tank caps for Kubota Ride-on Mowers, Utility Tractors and Zero Turn Mowers

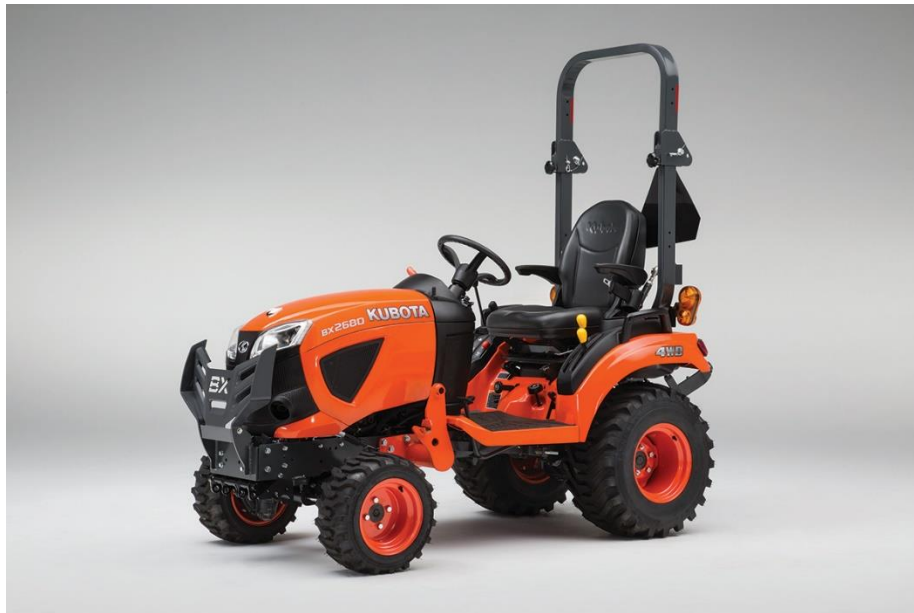
BX model compact utility tractor

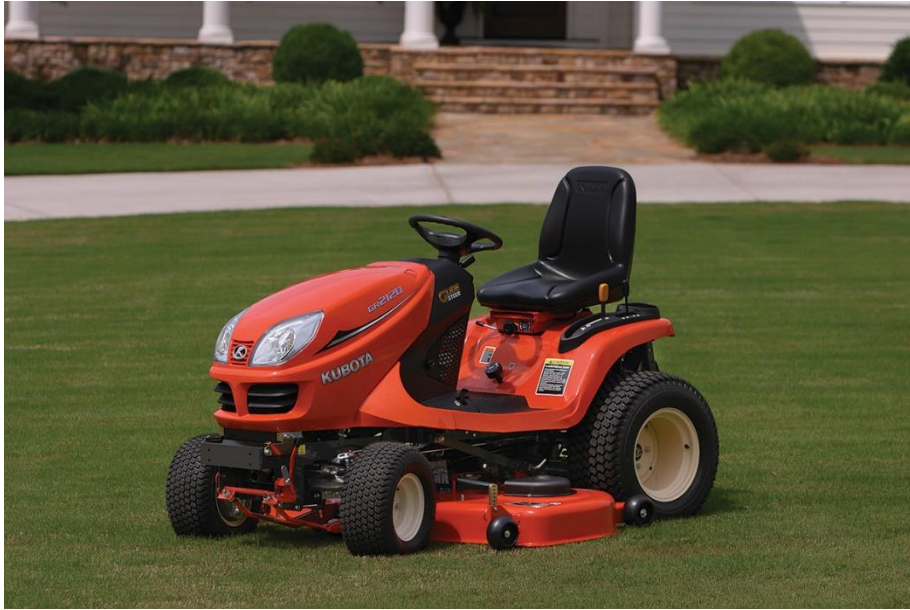
GR model ride-on mower

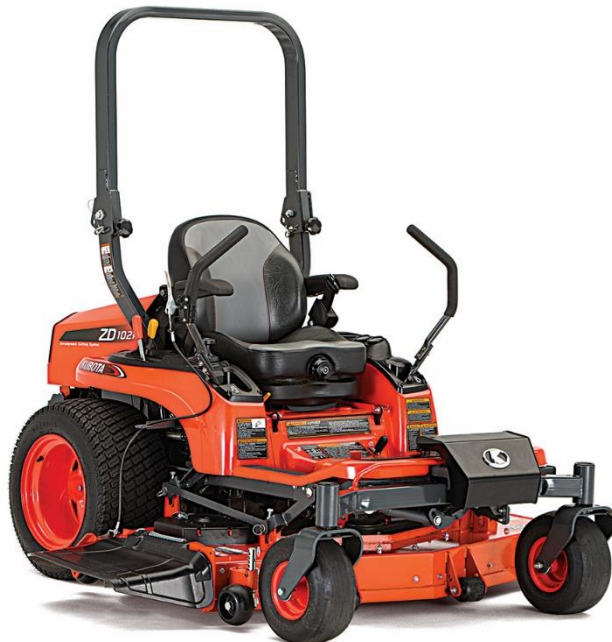
ZD model zero turn mower

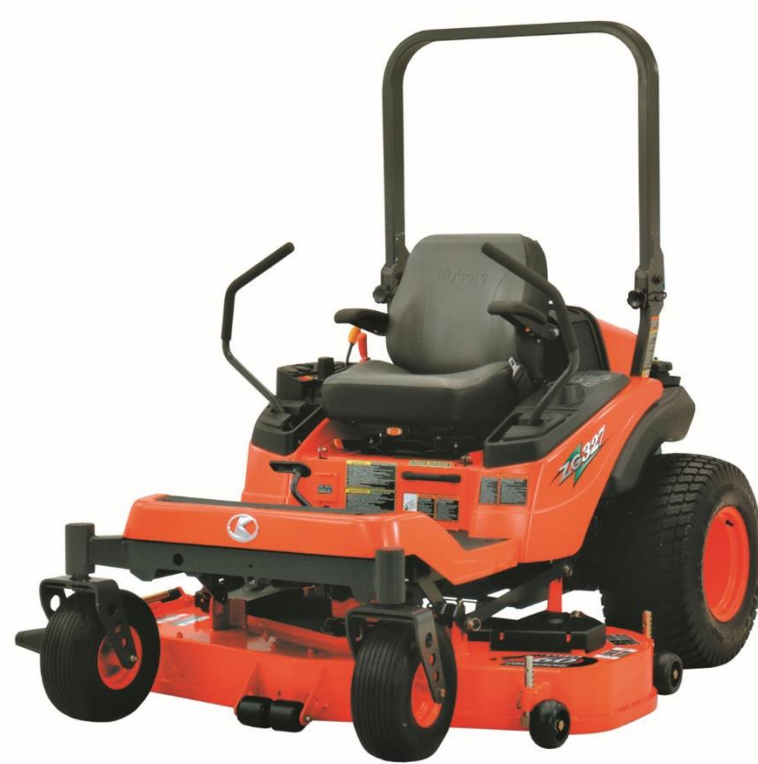
ZG model zero turn mower

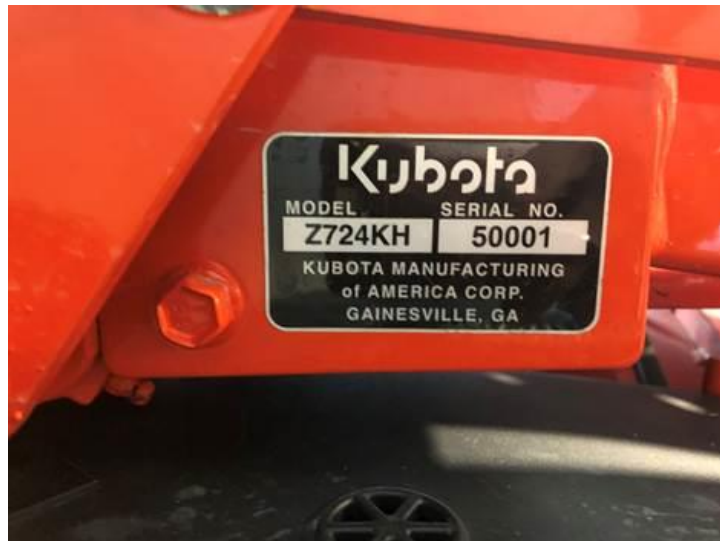
This recall involves model year 2014 to 2018 Kubota BX compact utility tractors, ZD and ZG diesel and gasoline-powered zero turn mowers, and GR ride-on mowers. The model number is printed on the side of the unit. Kubota is printed on the side of the mowers and tractors. The data plate contains the serial number and is also located on the side of the unit. The affected units are orange and black.

Data plate with model and serial number

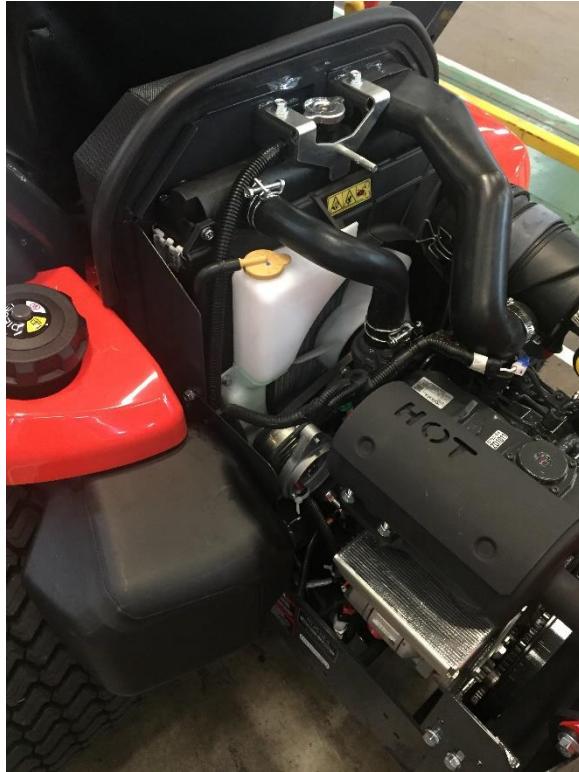
Kubota has discovered that under some overheat conditions, the cap of the radiator coolant reserve tank, if restricted, can come off and high temperature coolant may spray out, posing a burn hazard.

White coolant reserve tank with a yellow cap

**Consumers should immediately stop using the recalled Kubota Ride-on Mowers, Utility Tractors and Zero Turn Mowers. Customers are to be mailed a new cap by**

**Kubota Canada along with installation instructions. Consumers may also contact an authorized Kubota dealer for a free inspection and repair of the cap.**

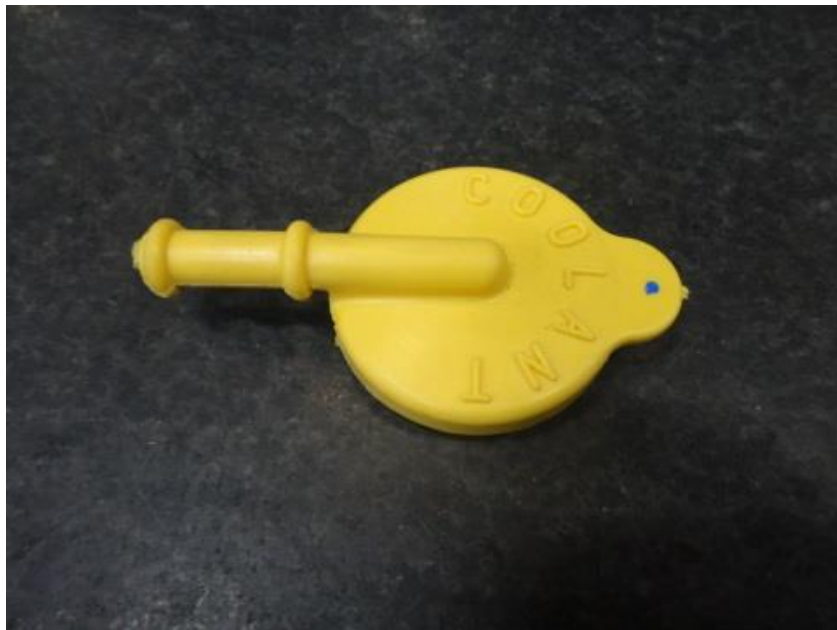
Replacement coolant cap
